HALLSDALE-POWELL UTILITY DISTRICT
CONSENT ORDER WPC14-0044

Corrective Action Plan
And Engineering Report

Prepared by Jacobs Engineering Group

March 5, 2015

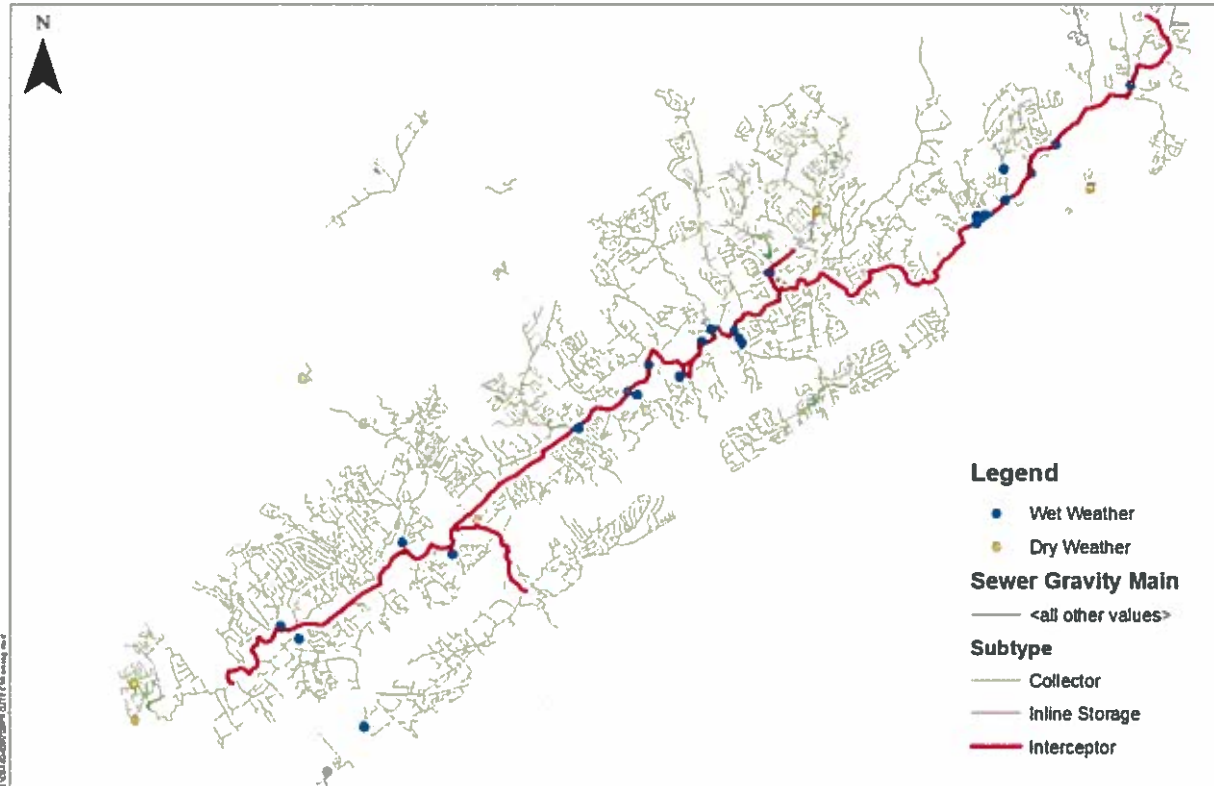
FIGURE 1 – Collection System SSO Location Map

Figure 1- Collection System SSO Location Map shows the location of the observed SSO events for the year 2014. It is readily apparent that the SSOs primarily occur along and/or adjacent to the Beaver Creek Interceptor and, with few exceptions, are the result of wet weather events where infiltration and inflow (I&I) overwhelm the collection system.

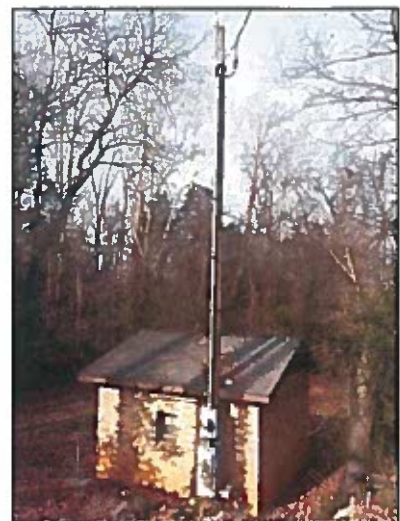
This pump station is located adjacent to Emory Road, near Barrington subdivision. The station is protected from unwanted entry by a cable secured between two bollards. The station itself is located on a dirt access road next to Beaver Creek inside a brick veneer concrete block building. There is municipal water onsite for any washdown activities that may be required. No signs of grease present in wetwell, which

would normally be seen from residential customers connected to station. The station contains two Gorman-Rupp suction lift pumps.

Provide safety cover for open wet well; replace failed pressure gauges; consider increasing security at station by installing fence around property, CCTV nearby influent lines for possible grease accumulation; install alarm light to alert pump faults; daily visual site checks.

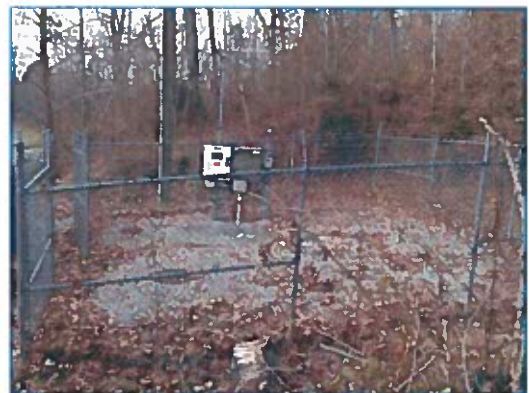
The pump station is located along Bell Campground Road. The station is surrounded by a gated chain link fence and has a security light overhead. The station contains two Homa submersible pumps. There were high grease levels observed at the site, but no major signs of grease reaching high elevations in the wet well. There is a bypass connection present onsite in the event of pump failure. There was no municipal water observed onsite.

The station is controlled by an ultrasonic level controller with redundancy from two float switches. All electrical components appear to be in good working order and manuals are present in cabinets.

Periodic checks to grease levels and pumping out when necessary. Pump station does not appear to have any major issues. Consider adding municipal water connection for any washdown activities. Daily visual inspection recommended.

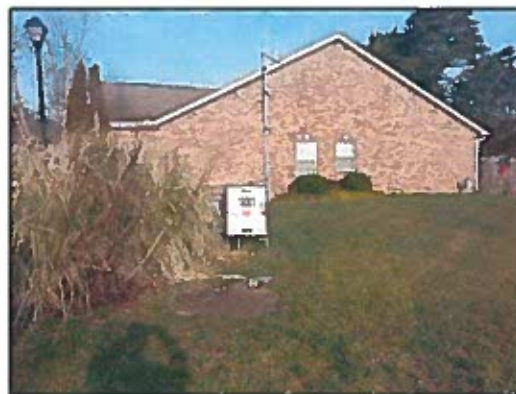
The pump station is located along LaChrista Way, inside Blakewood subdivision. The station is located adjacent to the road and is not surrounded by a fence. There is a creek nearby as well as a KUB sewer main running immediately next to the wetwell. The site lighting is provided by a nearby street lamp, although does not appear to be sufficient lighting for maintenance activities. The pump station houses two Myers submersible pumps. There were high grease levels observed within the wetwell at the liquid level and up the walls. There is not a bypass connection present onsite in the event of pump failure. The interior mounting brackets show signs of rust and corrosion. There was not connection visible to municipal water for washdown activities.

The station is controlled by an ultrasonic level controller with redundancy from two float switches. All electrical components appear to be in good working order and manuals are present in cabinets.

Periodic checks to grease levels and pumping out when necessary. Pump station does not appear to have any major issues. Daily visual inspection recommended due to close proximity to creek.

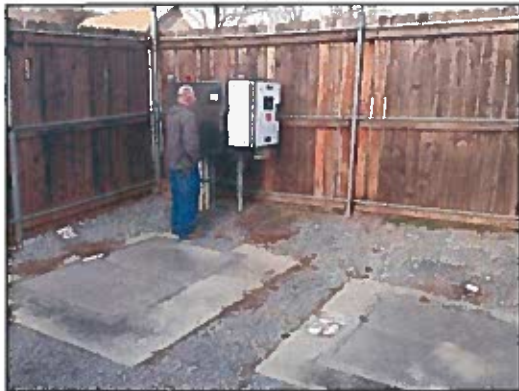
The pump station is located on E. Brushy Valley Drive. The two Flygt submersible pumps are housed inside a precast concrete rectangular wet well. The site is fenced off with wooden fence panels which help to hide it from the nearby subdivision. The station has one alarm light; however it is mostly hidden by the wooden fence panels surrounding the station. There is municipal water provided for washdown activities located on site.

The station is controlled by an ultrasonic level controller with redundancy from two float switches. All electrical components appear to be in good working order and manuals are present in cabinets.

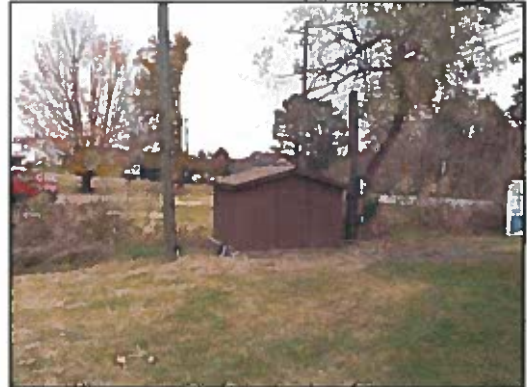
The pump station site is located along Tazewell Pike in a prefabricated metal building. The station houses two Gorman-Rupp suction lift pumps. The rear building foundation is severely undermined due to adjacent drainage ditch. There is also the possibility of inflow and infiltration from the nearby creek. There are no visual alarms present at the station. Headroom and pump accessibility is limited inside the station. No bypass connection present at site. Municipal water for washdown activities was not observed at the site.

The station is controlled by a pressure transducer with redundancy from two float switches mounted above the wetwell. The electrical panels show some signs of corrosion, due to lack of ventilation.

Foundation repair and stream bank stabilization should be addressed immediately, provide adequate ventilation and lighting inside station, consider adding visual alarm signal, bypass connection and municipal water supply for washdown activities.

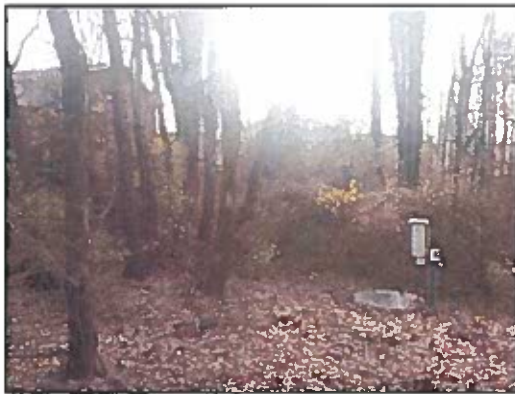
The pump station is located at the end of Wachese Lane and contains 3 Environment One submersible grinder pumps. The area surrounding the station is not fenced and municipal water is not present at the site. There is no onsite lighting at this station. This is a smaller station so a bypass connection is typically recommended. There is no visual alarm present at the station.

The control panels are in fair condition and appear to have no issues. The pumps are controlled by an internal pressure switch and has no back up level control.

Recommend providing fence and lighting around station to provide security and safety. Consider adding visual alarm to alert any station faults.

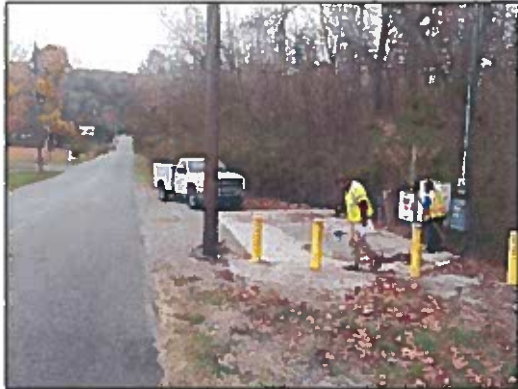
This pump station site is located on Mynatt Road. It contains two Flygt submersible pumps inside a precast circular wetwell. The site is currently not fenced and sits close proximity to the road. There have

been bollards installed to provide protection from oncoming traffic. Municipal water is available onsite for washdown activities and a bypass connection is present. Heavy grease and rags observed in wetwell which cause clogging during high flows.

Grease and rags should be addresses and monitored by daily visual inspections at the site. Recommend installing fence, additional bollards and lighting at the site to increase security and safety.

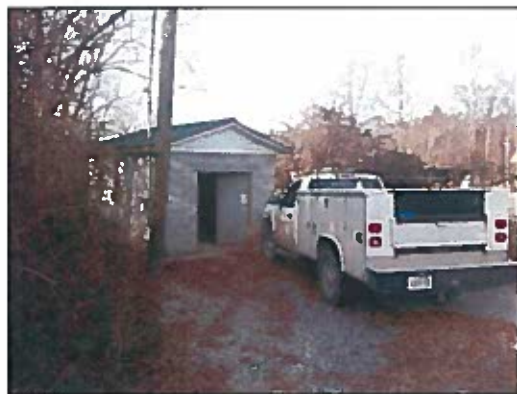
This pump station site is located on Schaad Road. It contains two Gorman-Rupp two-step suction lift pumps inside a concrete block building. The site is not fenced and is secured only by the locked double doors. The station is easily accessible by a gravel drive. Municipal water is available onsite for washdown activities. The existing wetwell shows signs of grease and debris buildup. The station showed signs of

recent overflows, due to pump failure that has been repaired. The pumps show signs of corrosion, due to limited ventilation from the existing exhaust fan. Lighting inside the station is adequate, but could be improved. There is a pole mounted exterior light just outside the station.

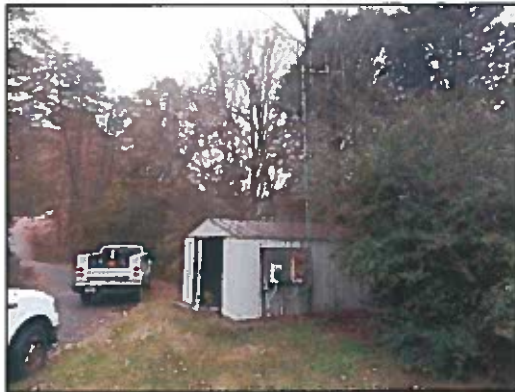
This pump station site is located on Yellowbrick Way. It contains one Keen submersible grinder pumps inside a precast concrete wetwell. There is no guiderail system, which could cause pump to turn over. The pumps are located inside a prefabricated metal building with low head clearance and very poor lighting. There is no exterior lighting or fence surrounding the station. Municipal water is not available

onsite for washdown activities and there is no bypass connection.

Station is in need of upgrade/replacement. Consider adding additional pump, guide rail system or other method of securing pumps, upgrade interior and exterior lighting, add ventilation fan.

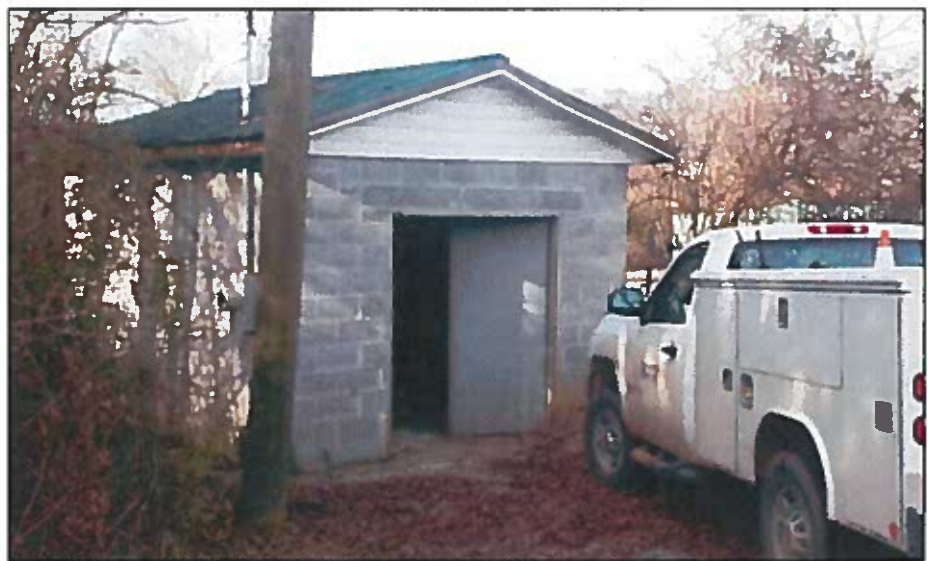
This station is currently at high risk for overflow events during wet weather. Under existing conditions the inflow and infiltration during wet weather along with the existing flow overwhelm the station. Efforts to reduce inflow and infiltration into the system will help to decrease this from occurring; however this is not an immediate solution.

Schaad Road Pump Station at LaChrista Way. Under high flow volumes when these two stations are running concurrently, the Schaad Road pump station is overpowered by the increase in total dynamic head and the lack of storage in the wetwell results in sanitary sewer overflows.

Additionally, it is recommended that the wetwell at Schaad Road be increased to 6-foot diameter for increased storage volume. The existing wetwell is in poor condition and undersized for wet weather flows.

It is recommended that the 4-inch force main be replaced with a 6-inch diameter forcemain from LaChrista Way to the discharge gravity manhole approximately 2,600 LF downstream. This would decrease the total dynamic head on the pumps and decrease the probability of sewer overflows when both pumps at Schaad Road and Blakewood pump stations are running. The existing pumps at Schaad Road would need to be evaluated to determine their new operating point and whether replacement is necessary.

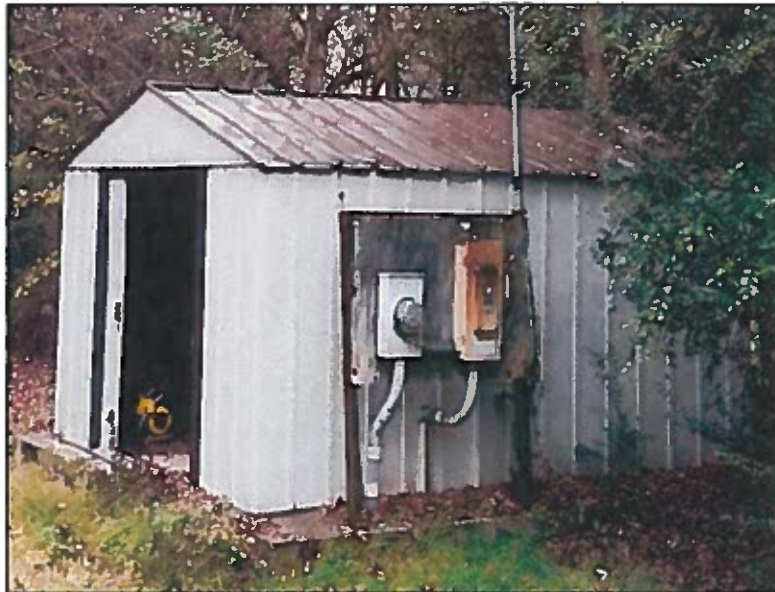
Yellowbrick Pump Station

With only one installed pump at this site and the poor condition of the electrical and control system, this pump station should be a high priority for repair/replacement.

The existing pump station site does not allow for any expansion in size and surrounding property owners have not indicated interest in discussing the sale of additional land to HPUD. The current building housing the pumps and controls is not reusable. This station could be replaced with a small duplex packaged pump station that would completely replace the existing site. This would provide much greater reliability and reduce future sanitary sewer overflows.

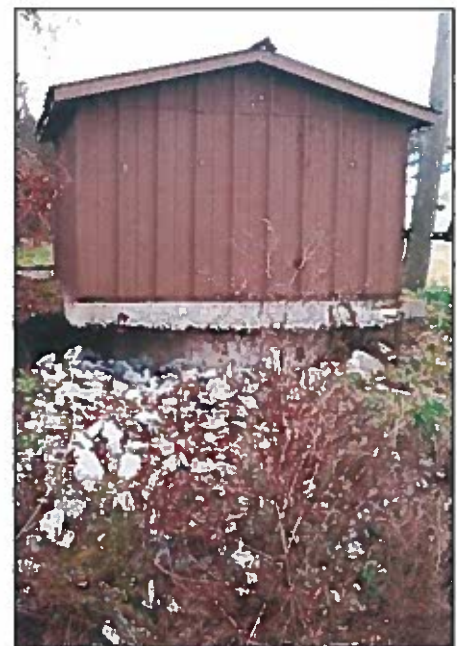
The foundation of this pump station needs to be remedied before erosion causes a major overflow into the adjacent creek. The slab that is currently cantilevered over the eroded bank appears to be in satisfactory condition. The foundation needs to be properly supported and the stream bank armored with larger stone to reduce future erosion.

The adjacent rear view photo of Campbell's Point Pump Station shows past erosion mitigation efforts via the placement of rip rap at the foundation. A small creek lies at the bottom of the photo just off image

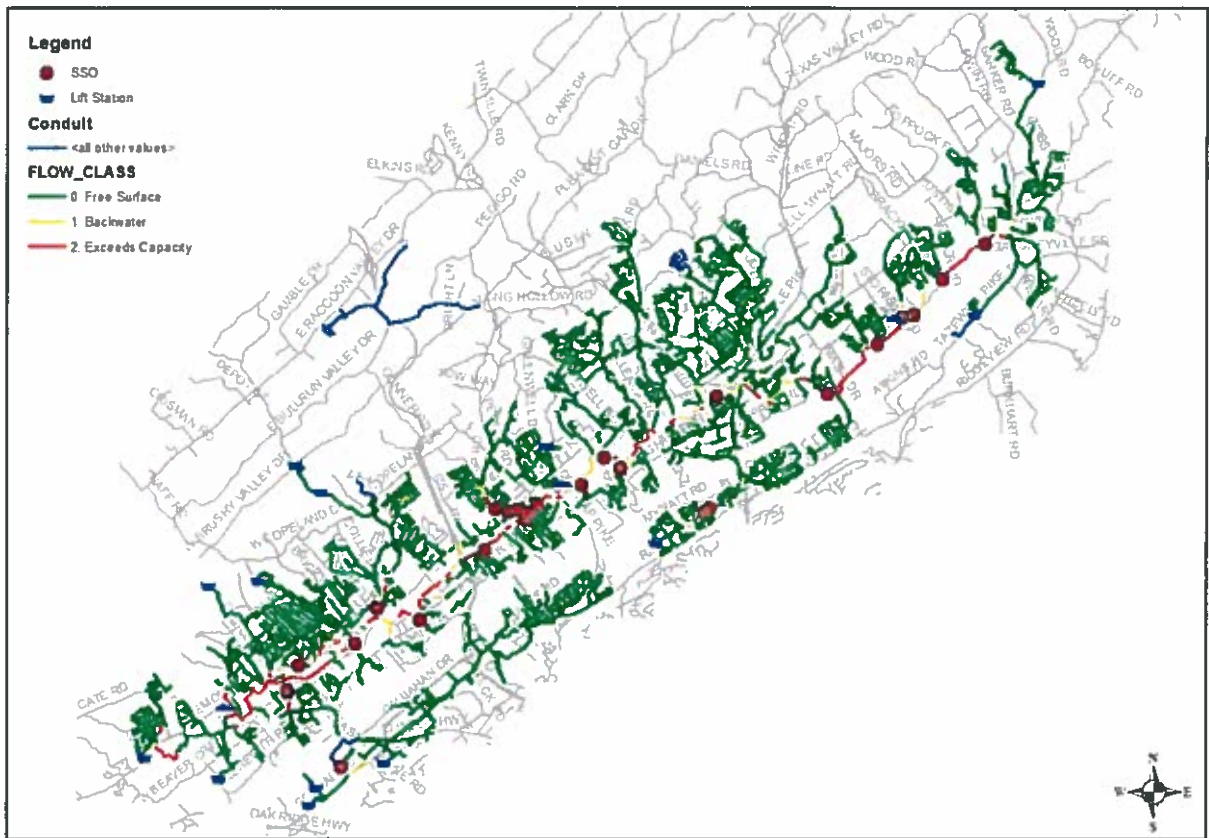
FIGURE 5 – Existing System WWF Assessment

The WWF capacity assessment indicated insufficient capacity and backwater along the entire interceptor and several trunk lines. The lack of capacity to convey the full magnitude of base flow and RDII entering the system creates backwater conditions which ultimately develops into manhole flooding and overflows. Figure 5, on the following page, presents the SSO's as indicated by the model and capacity flow classification for the collection system under existing design storm. As presented in Figure 5, a majority of the SSO's are occurring along the interceptor.
