HALLSDALE-POWELL UTILITY DISTRICT
CONSENT ORDER WPC14-0044

Corrective Action Plan
And Engineering Report

Prepared by Jacobs Engineering Group

March 5, 2015

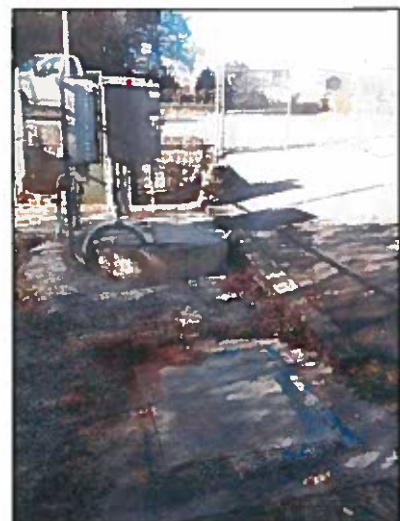
All electrical and control panels appear to be in good order. Pumps are controlled by a level transducer and floats as backup.

No critical issues observed. Consider adding onsite lighting for safety and security; consider adding bypass connection if not already present.

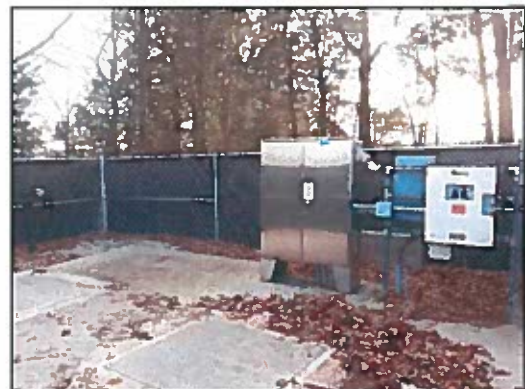
This pump station site is located on Thebes Lane. It contains two Flygt submersible pumps inside a precast circular wetwell. The site is surrounded by a chain link fence and is easily accessible via an asphalt paved drive. There is onsite lighting nearby as well as a secondary power

receptacle. Municipal water is available onsite for washdown activities and a bypass connection is present.

No critical issues observed. Some minor grease in wetwell, recommend observation and cleaning when necessary.

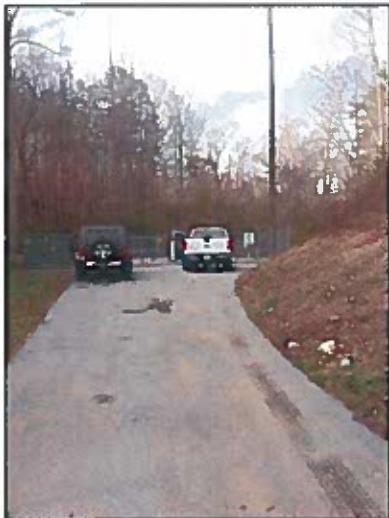
This pump station site is located in Copeland View subdivision. It contains two Myers submersible pumps inside a precast circular wetwell. The site is surrounded by a chain link fence and is easily accessible via an

asphalt paved drive. There is decent lighting at the site. Municipal water is available onsite for washdown activities.

No critical issues observed. Water observed in valve vault, recommend grouting pipe penetrations and adding sump pump or drain.

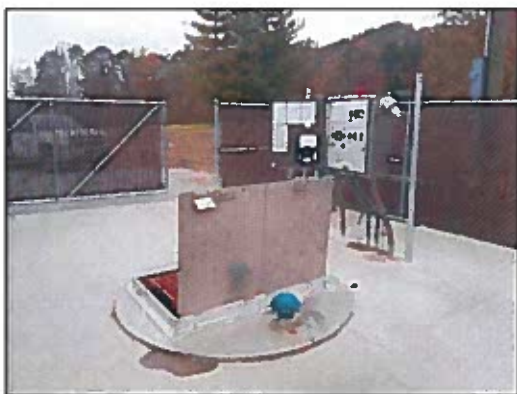
Mountain Shadows

This pump station site is located on Tazewell Pike. It contains two Flygt submersible pumps inside a precast circular wetwell. The site is surrounded by a chain link fence and is easily accessible via a gravel drive. There is onsite lighting nearby as well as a secondary power receptacle. Municipal water is available onsite for washdown activities and a bypass connection is present.

All electrical and control panels appear to be in good order. Pumps are controlled by a level transducer and floats as backup.

No critical issues observed. Water observed in valve vault, recommend grouting pipe penetrations and adding sump pump or drain.

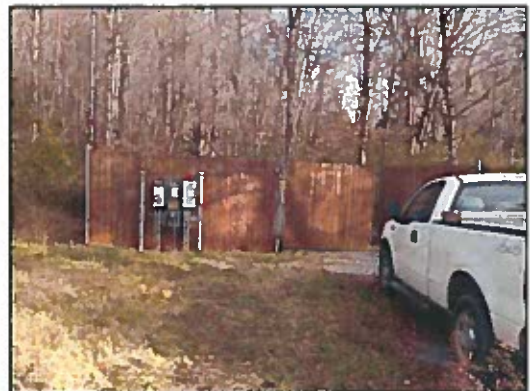
All electrical and control panels appear to be in good order. Pumps are controlled by a level transducer and floats as backup.

Consider adding additional lighting for safety and maintenance activities. Prefab FRP containers housing pumps and controls are extremely difficult to access, consider site built enclosure to protect pumps and controls from weather and make equipment more accessible.

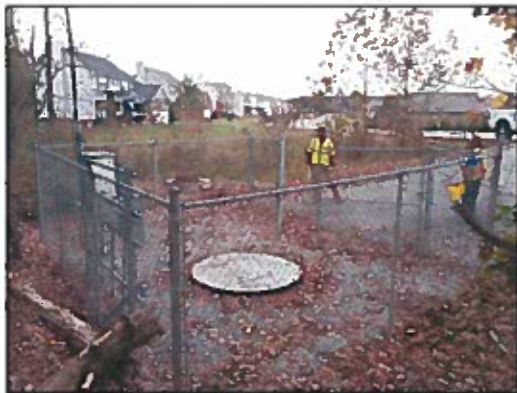
The pump station is located at the end of County Rose Lane and contains 3 Environment One submersible grinder pumps inside a fiberglass reinforced plastic wetwell. The area surrounding the station is fenced and municipal water is not present at the site. There is no onsite lighting at this station. There is no visual alarm present at the station. High grease level were observed in the station

The control panels are in fair condition and appear to have no issues. The pumps are controlled by an internal pressure switch and has floats as a backup measure.

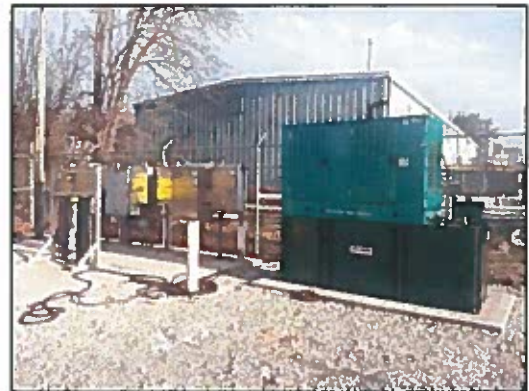
All electrical and control panels appear to be in good order. Pumps are controlled by an ultrasonic level transmitter and floats as backup.

No critical issues observed. Water observed in valve vault, recommend adding sump pump or drain. Occasional overflows at station appear to be due to collection system inflow and infiltration.

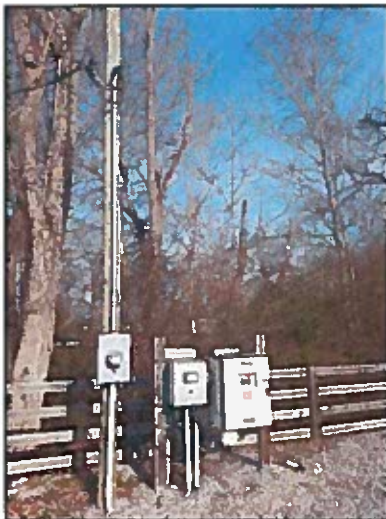
Weaver Road

This pump station site is located on Weaver Road. It contains two Flygt submersible pumps inside a fiberglass reinforced plastic wetwell. The site is currently surrounded by a wooden fence but offers a low level of security. Municipal water is available onsite for washdown activities and a bypass connection is present. The discharge valves are located inside the wetwell which makes them difficult to access for maintenance.

All electrical and control panels appear to be in good order. Pumps are controlled by a level transducer and floats as backup.

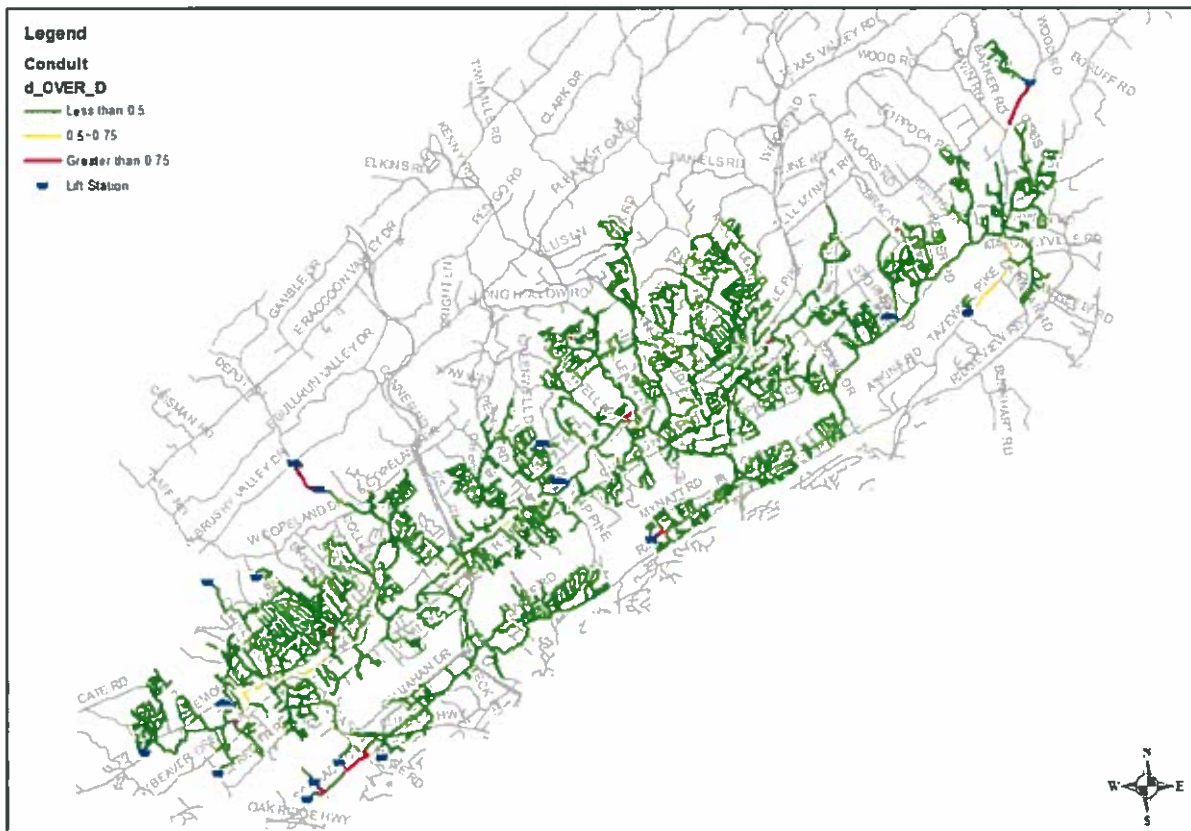
FIGURE 3 – HPUD DWF Capacity Assessment

Figure 3 presents the DWF capacity assessment results for the existing system flows. The interceptor ranges in size from 15-inch to 36-inch and is flowing less than 75 percent full. The highlighted lines greater than 75 percent are force-mains.

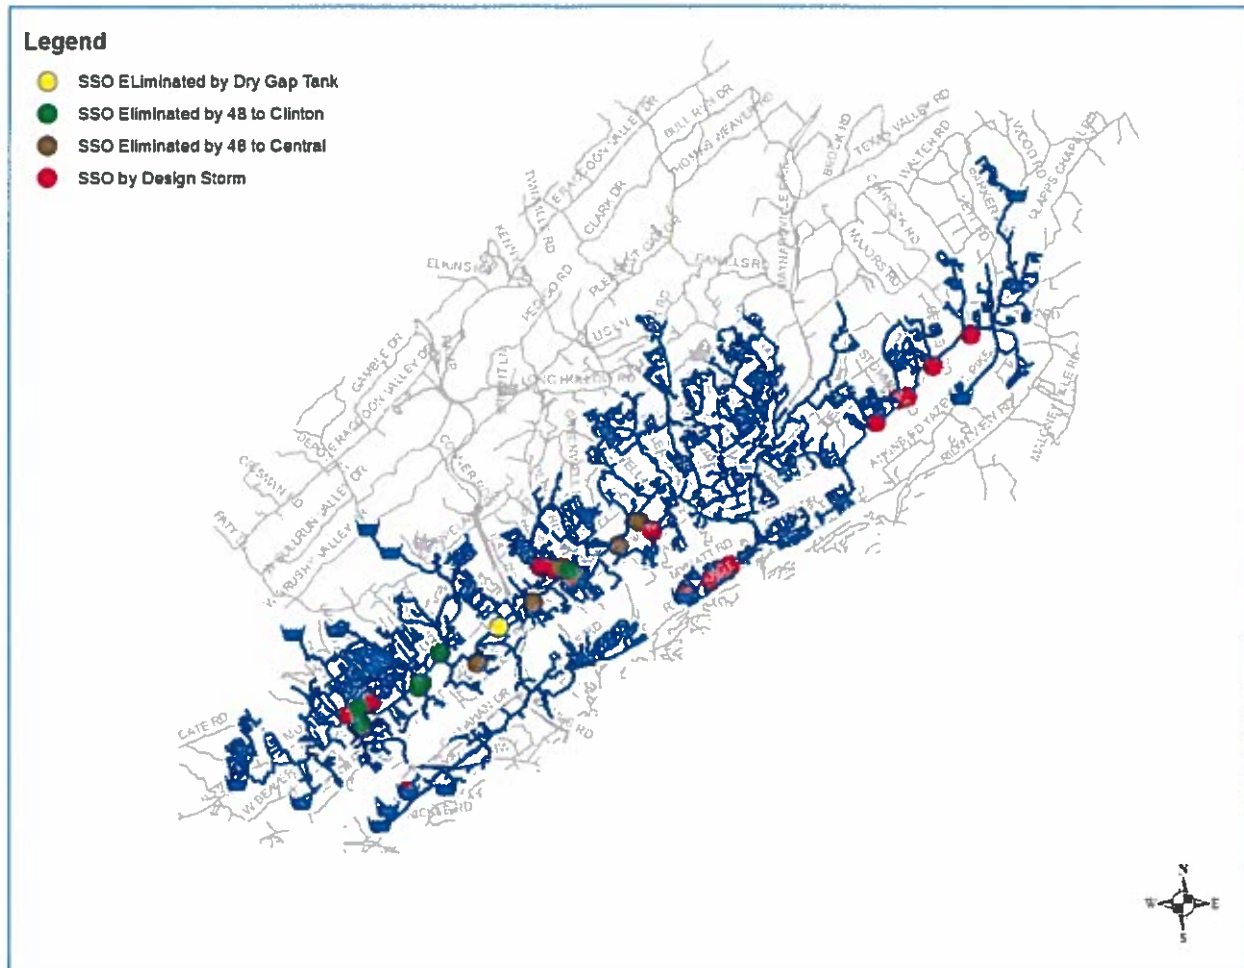
FIGURE 6 - SSO Removal by Improvement

existing 30 and 36-inch sewers to Central Avenue. The increased capacities provided by the 48-inch sewer through Central Avenue eliminated a large number of SSO's. Figure 5 presents the predicted eliminated overflows by improvements.

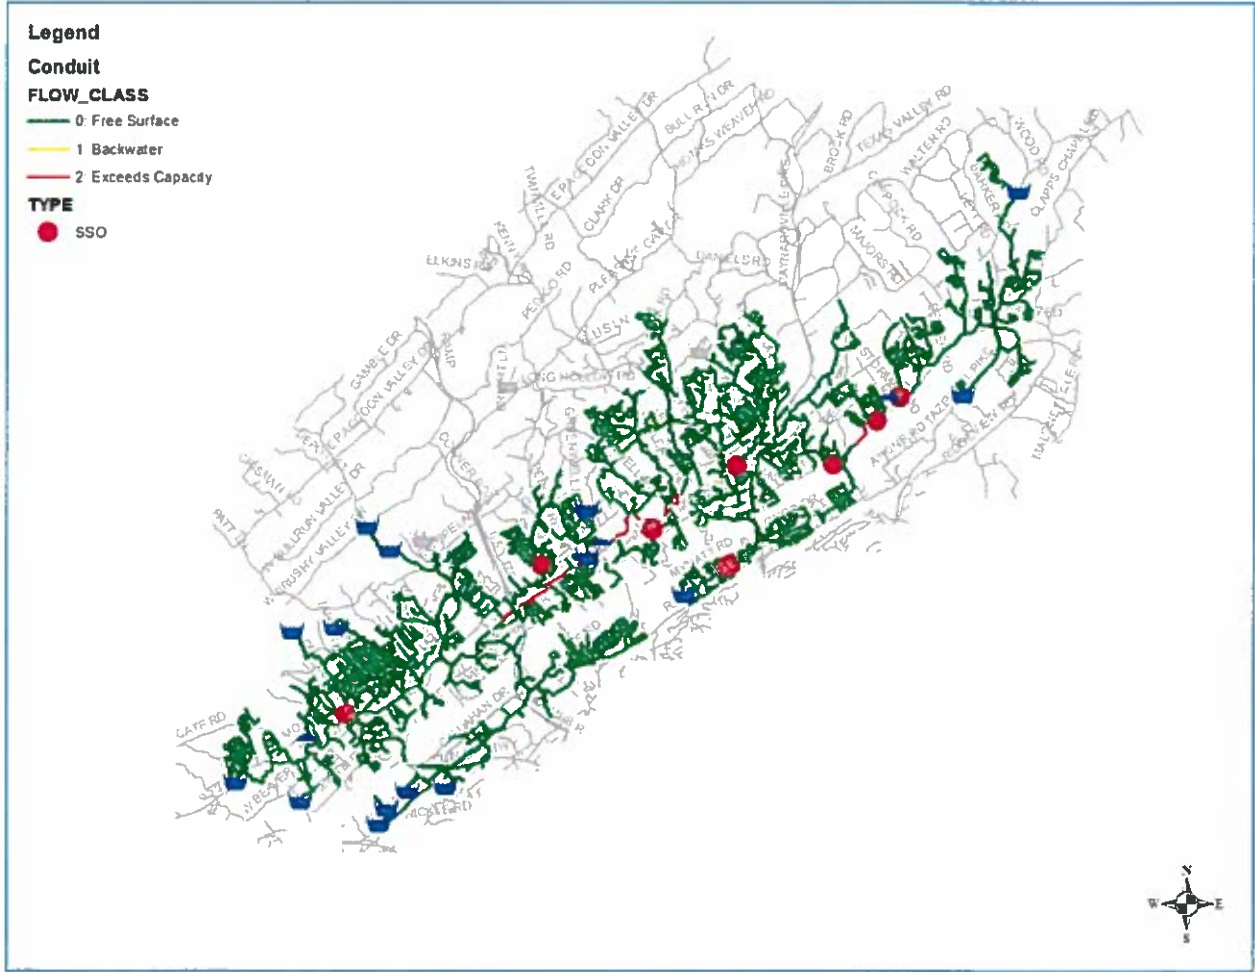
Figure 9: WWF Capacity Analysis

The 2025 WWF capacity evaluation was performed through use of the 2025 DWF and the design storm event. The 2025 WWF capacity assessment indicated that only a few SSO's are predicted. These areas have been identified as localized improvements that are necessary to allow flows to reach the interceptor.

The high density flow monitoring recommended will verify if these localized projects are necessary or a function of the base flow and RDII allocation. Figure 9 presents the 2025 WWF capacity assessment.
